PHOTO DOCUMENTATION

The House

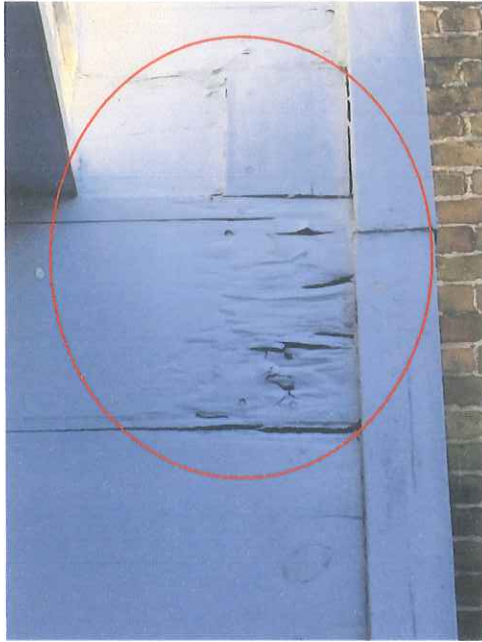
Right side of porch, showing signs of wood deterioration.

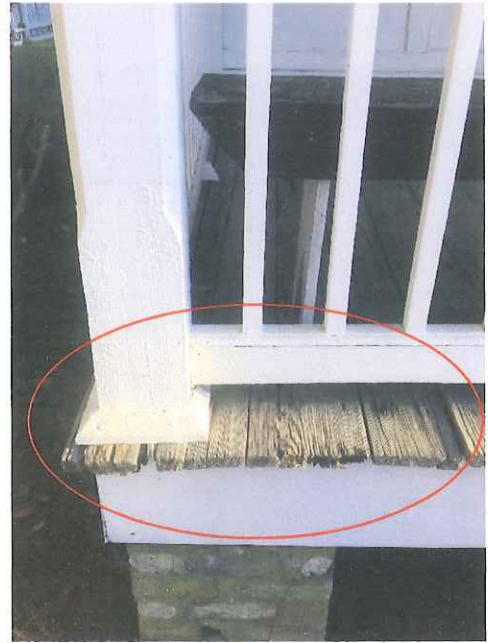
Porch deck boards showing wear.

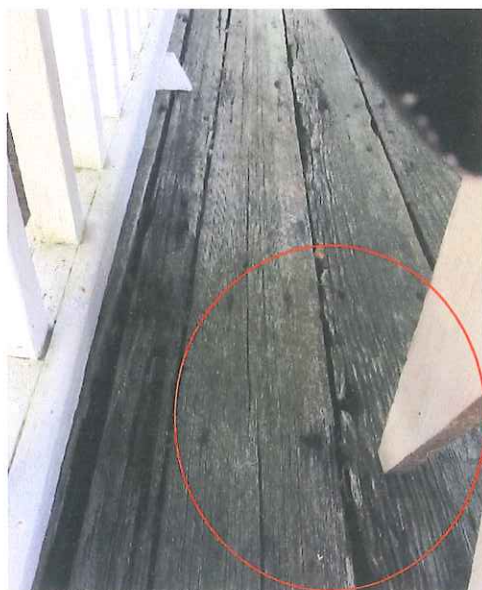
Porch deck boards showing wear.

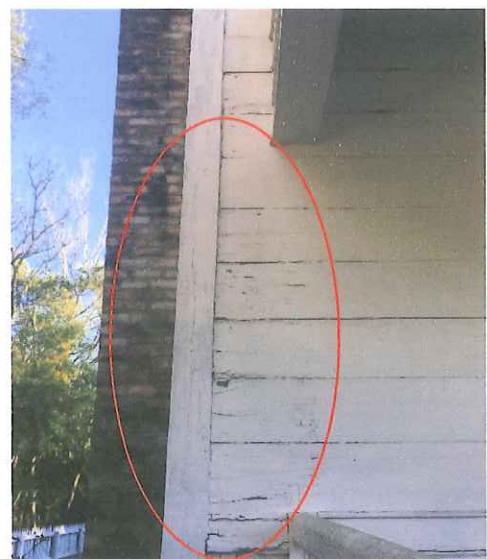
Left side of porch, showing signs of wood deterioration.

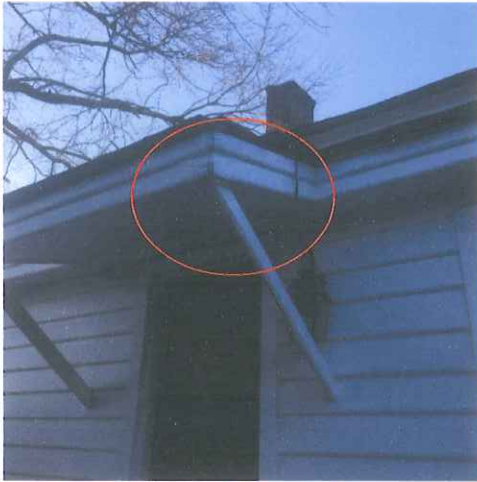
Back stoop, notice the corner showing signs of wood deterioration.

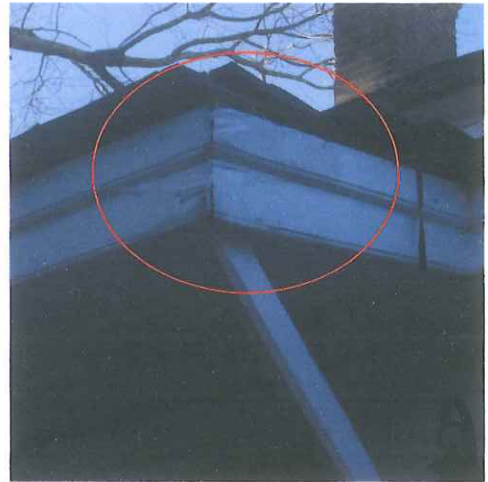
Back stoop, notice the corner showing signs of wood deterioration (close-up).

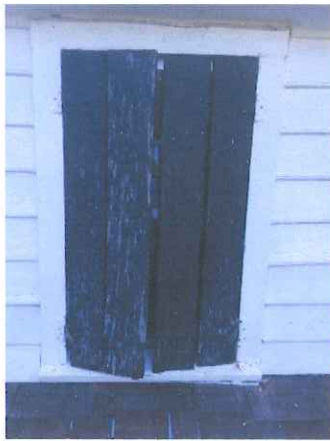
The shutters are the primary defense for each of the windows in the JKH. As you can see they take a real beating from the elements. The wood simply dries out and hardware fails leaving them flopping in the wind. This causes damage to the windows.

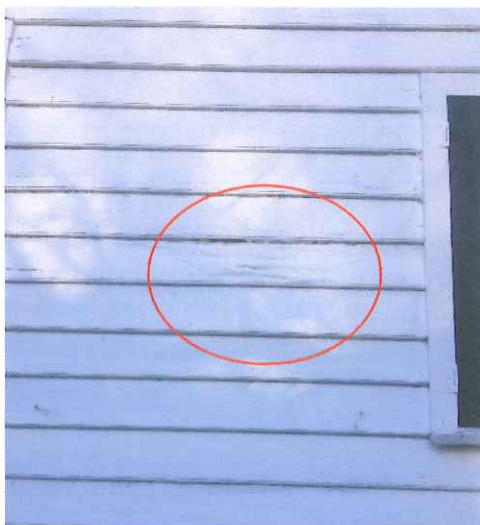
View of the wall between the kitchen & dining room windows, just above the ac unit, showing signs of wood deterioration.

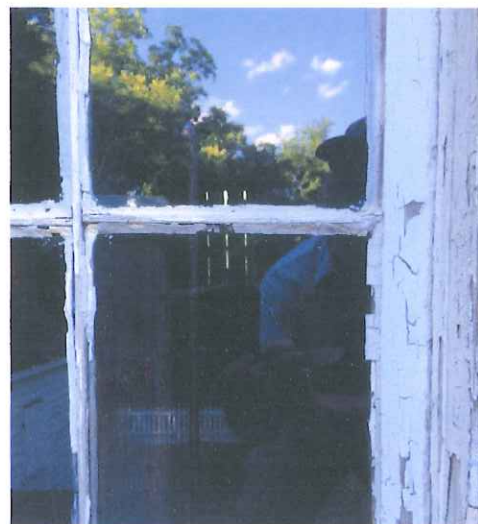
This photo shows the deterioration of the windows sashes and the loss of glazing needed to hold the panes in place.

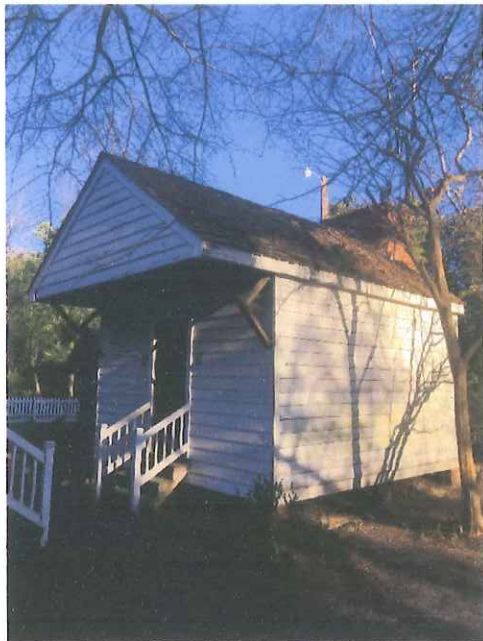
View of the Cook House, we are working with a tree removal company to trim back the limbs over the top of the Cook House.

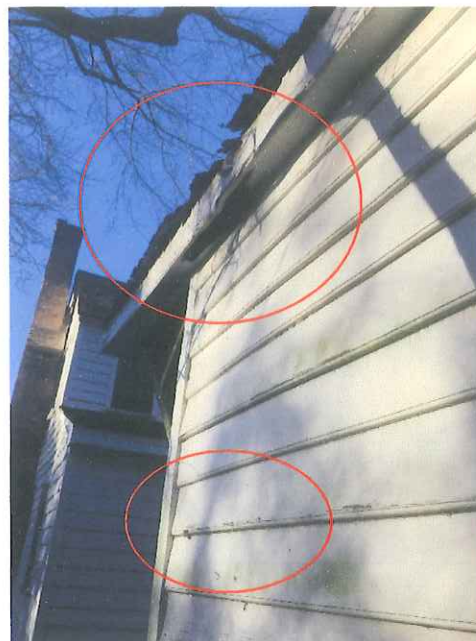
Notice the deterioration of the fascia and soffit, evidence of water running down the rafter, pooling in the soffit.

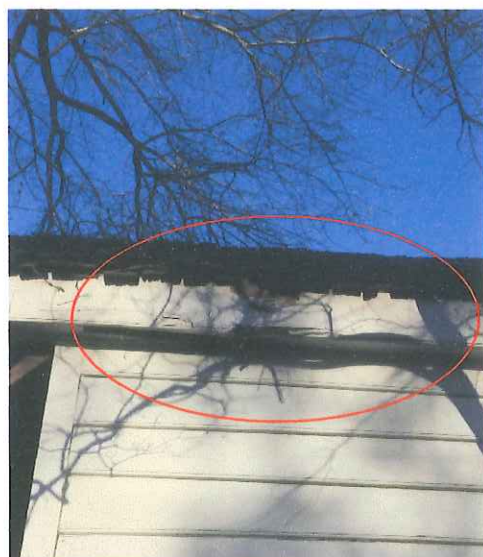
Advanced deterioration of the fascia and soffit.

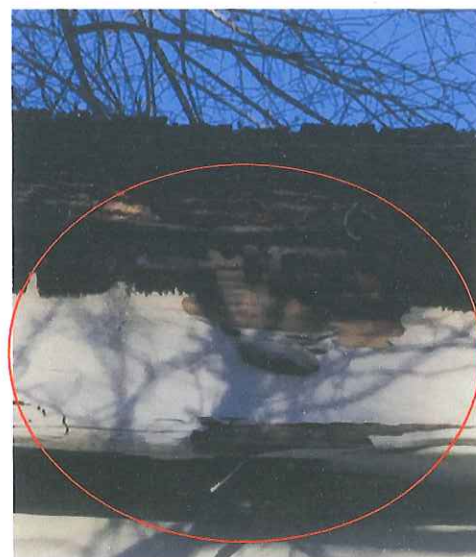
Advanced deterioration of the fascia and soffit (close-up).

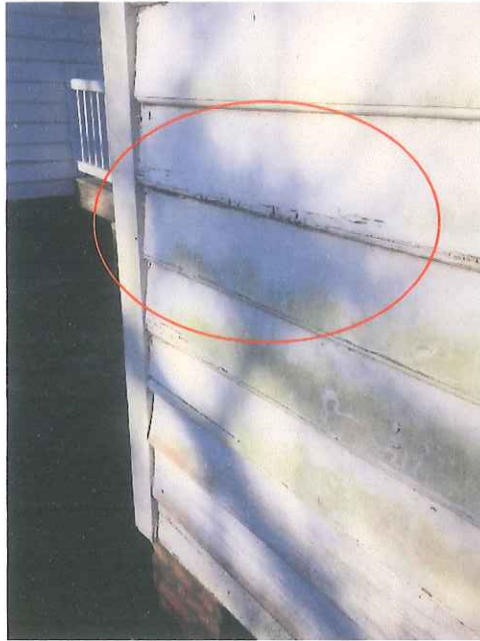
Notice the deterioration of the siding along the bead edge.

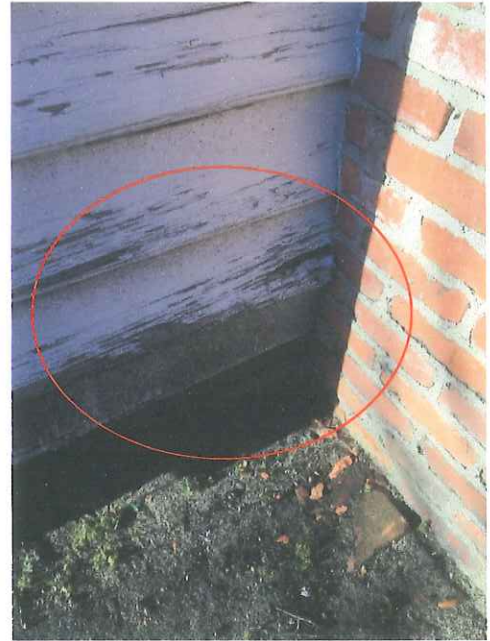
Cook house wall/chimney - showing signs of deterioration and needing paint.

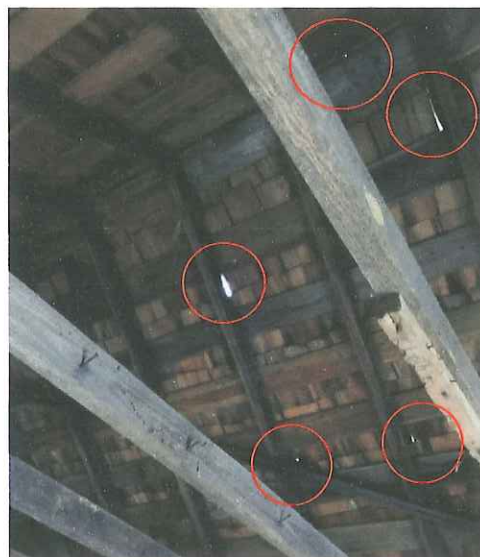
View of the Cook House roof from inside. Middle left side, notice the 5 holes.

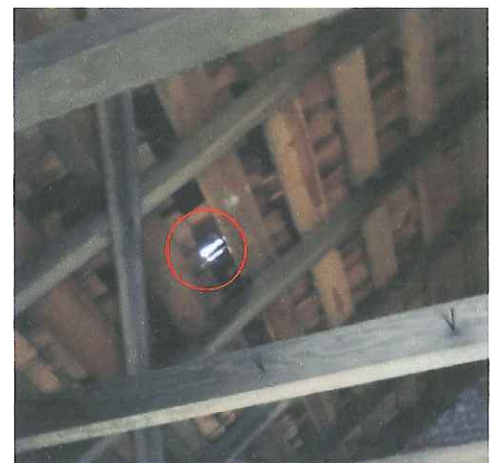
View of the Cook House roof from inside. Middle left side, notice the large hole hidden by a rafter in the previous photo.

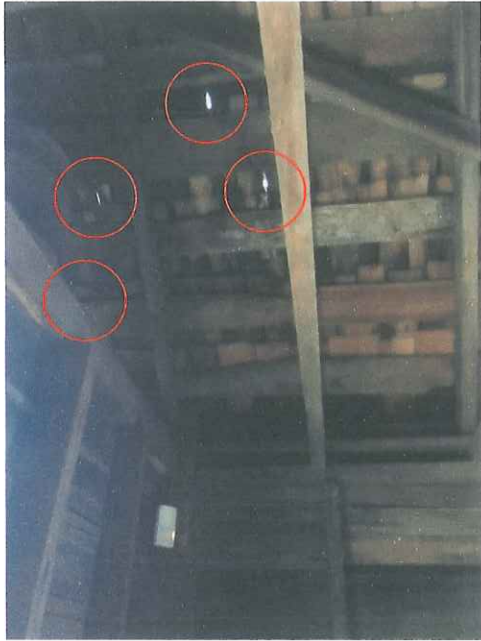
*View of the Cook House roof from inside.
Front, left side along the wall, notice three
holes.*

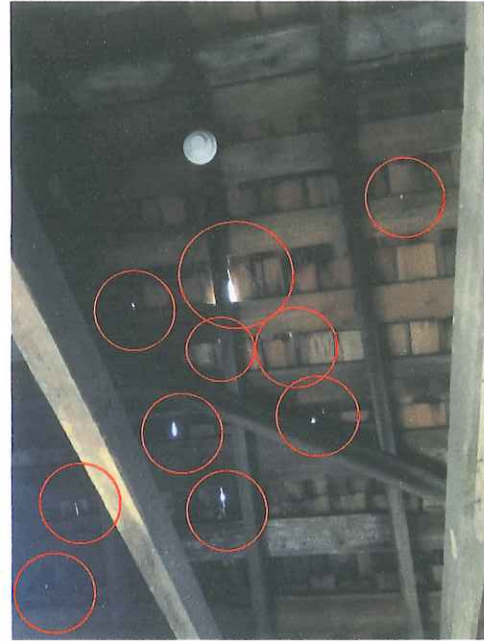
*View of the Cook House roof from inside.
Front, left side from gable down, notice 10
holes in the roof.*

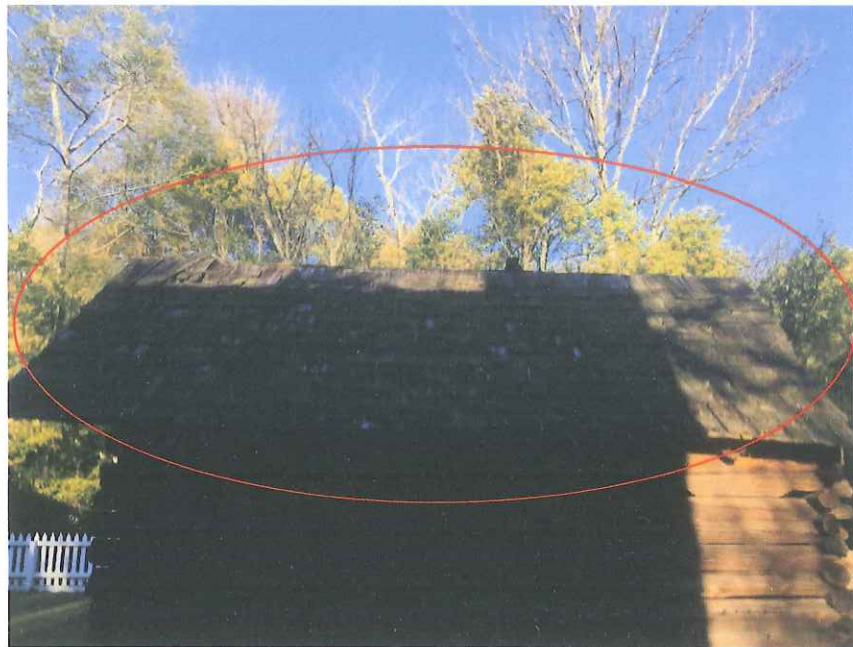
Side view of the Corn Crib roof, notice the deterioration of the shake shingles.

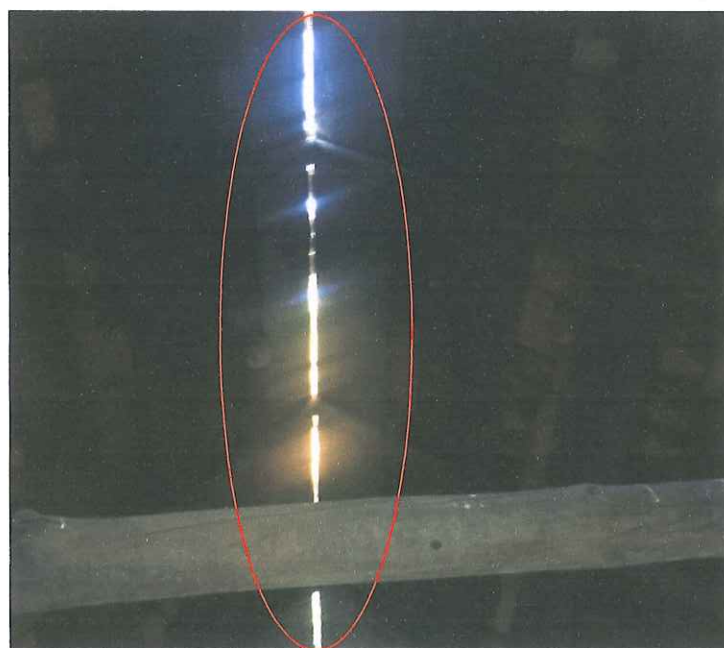
Interior roof of the Corn Crib, notice the complete deterioration of the ridgeline of the roof.

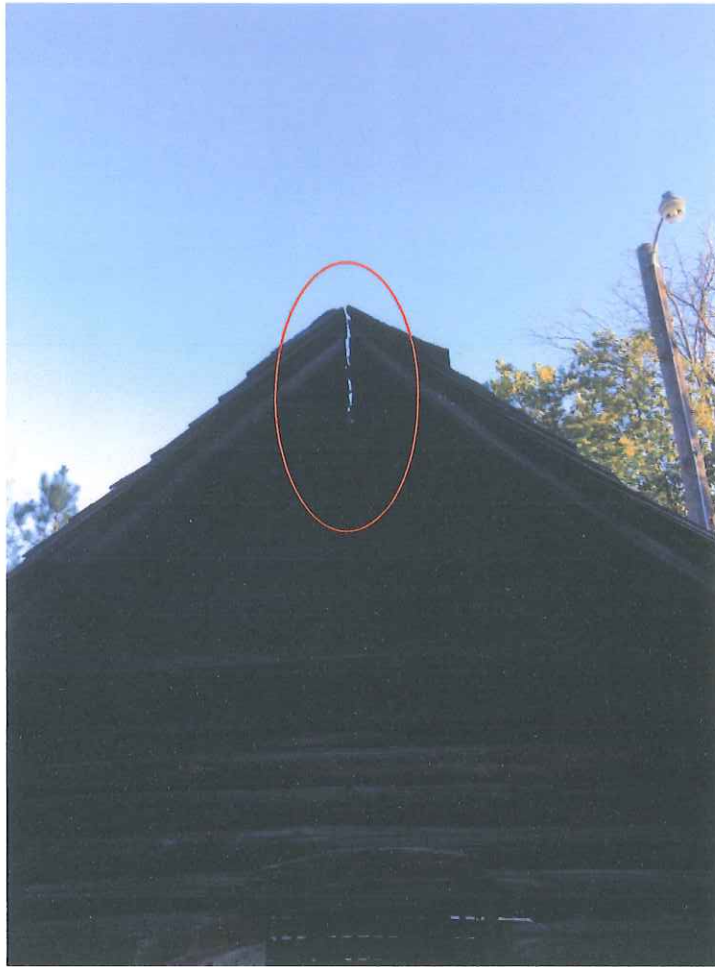
*Notice the separation in the rafters and the deterioration of the
ridgeline of the roof.*
